# Turtle Mitigation for Road and Highway Projects

Pembroke District MNR – Interim Guidelines

Version 1.0 (April 2014)

**Draft Turtle Mitigation for Road and Highway Projects  
Pembroke District MNR Interim Guidelines  
(Version 7 – April 2, 2014)**

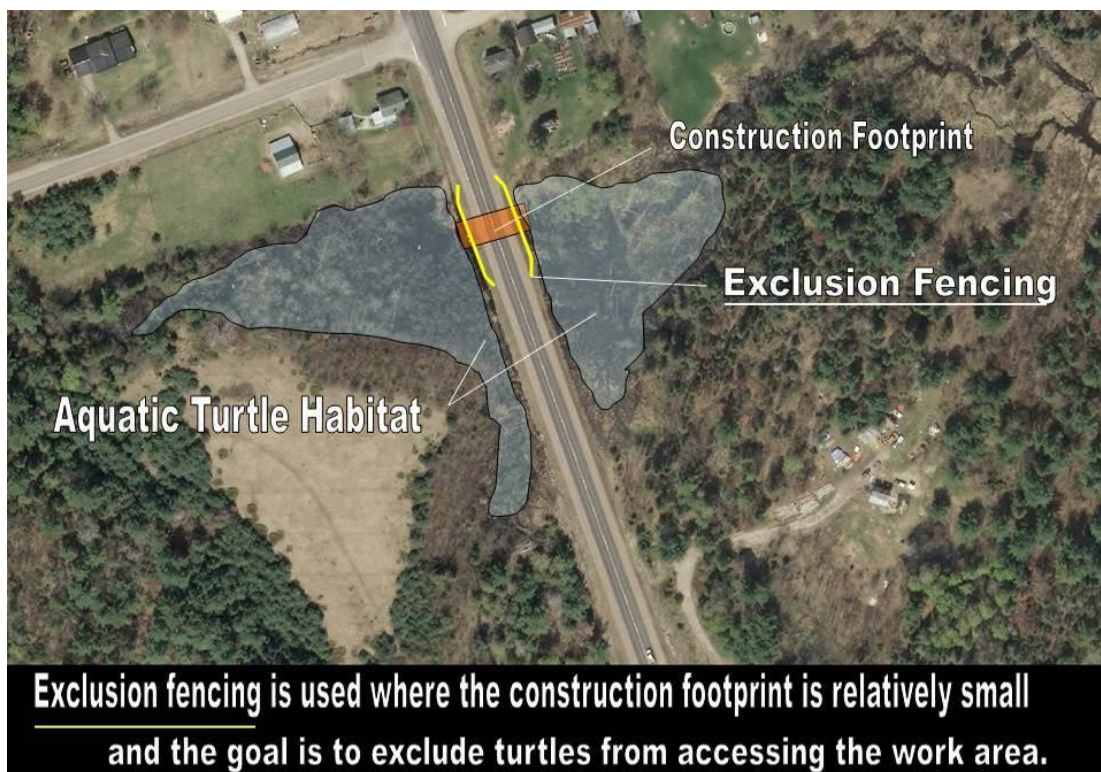
Figure 1: For minor culvert replacement projects exclusion fencing should extend a minimum of 10 meters from the limit of construction disturbance.

Install exclusion fencing for a minimum distance of 10 meters beyond the actual footprint of your work area. Exclusion fencing should be placed on both sides of the road and both sides of the culvert. It should be installed so that there are no gaps at the culvert and extend **along the water's edge** at right angles away from the culvert. Fencing should be angled 45 degrees up the bank, terminate before it becomes a safety risk to drivers, and then angled back down the bank at 90 degrees for an additional 1-2 metres (to direct turtles away from the road). If the road is closed to traffic, closing the road off with fencing at night from turtles entering the work area is the best method for effective exclusion.

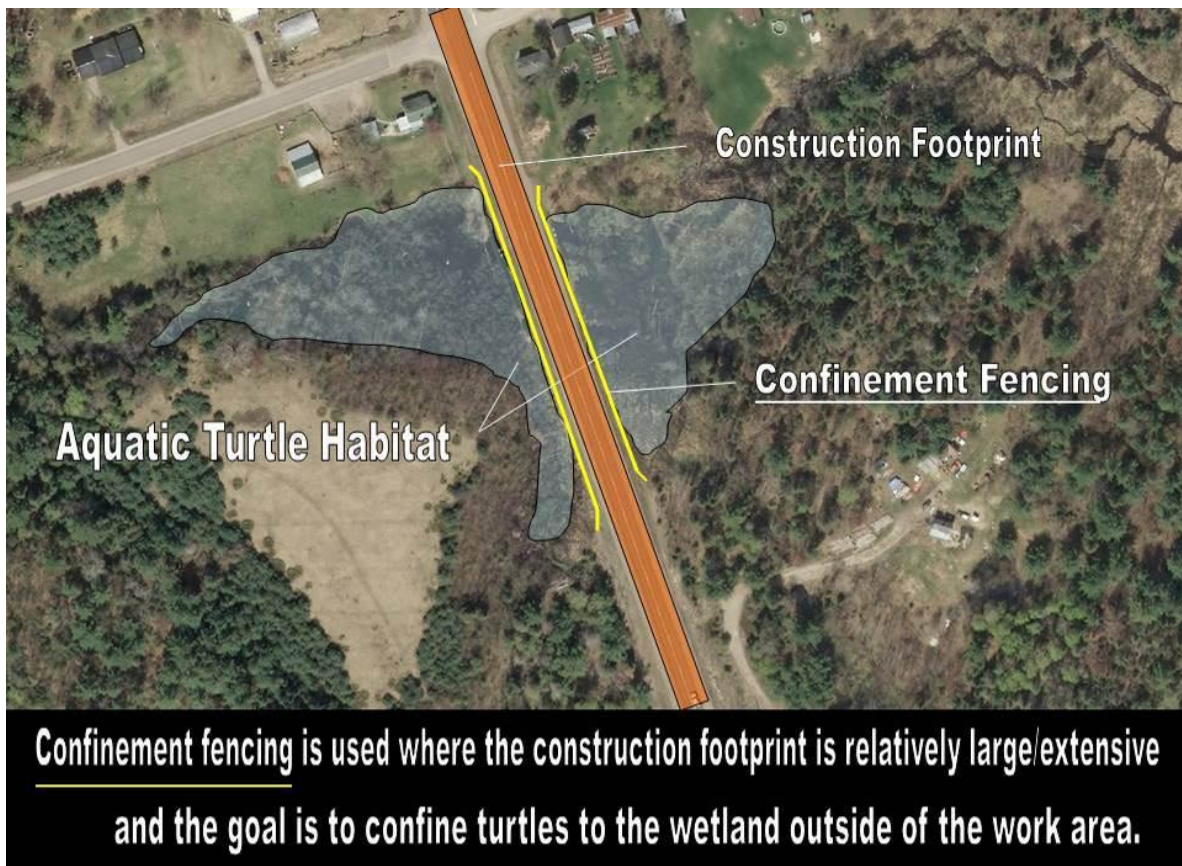
Figure 3: For road and shoulder improvement projects confinement fencing should extend a minimum of 10 meters past the extent of the habitat.

The primary difference with confinement fencing is that this fencing extends along the entire stretch of adjacent wetland habitat terminating a minimum of 10m past the extent of the habitat. Also, the terminating wing walls of the fencing angle back towards the wetland in order to encourage any turtles following the fencing to be redirected back to the wetland away from hazardous environments associated with the road.

Fencing should be installed a minimum of 10 meters beyond the extent of the turtle habitat feature. However, in situations where suitable habitat like water features end or is bound by rock outcrops silt fencing should be installed between the two faces with no gaps (See Figures 3 & 4 below). Rock or suitable fill may be required within the ditch along a rock cut to support the exclusion fence or seal off any gaps.

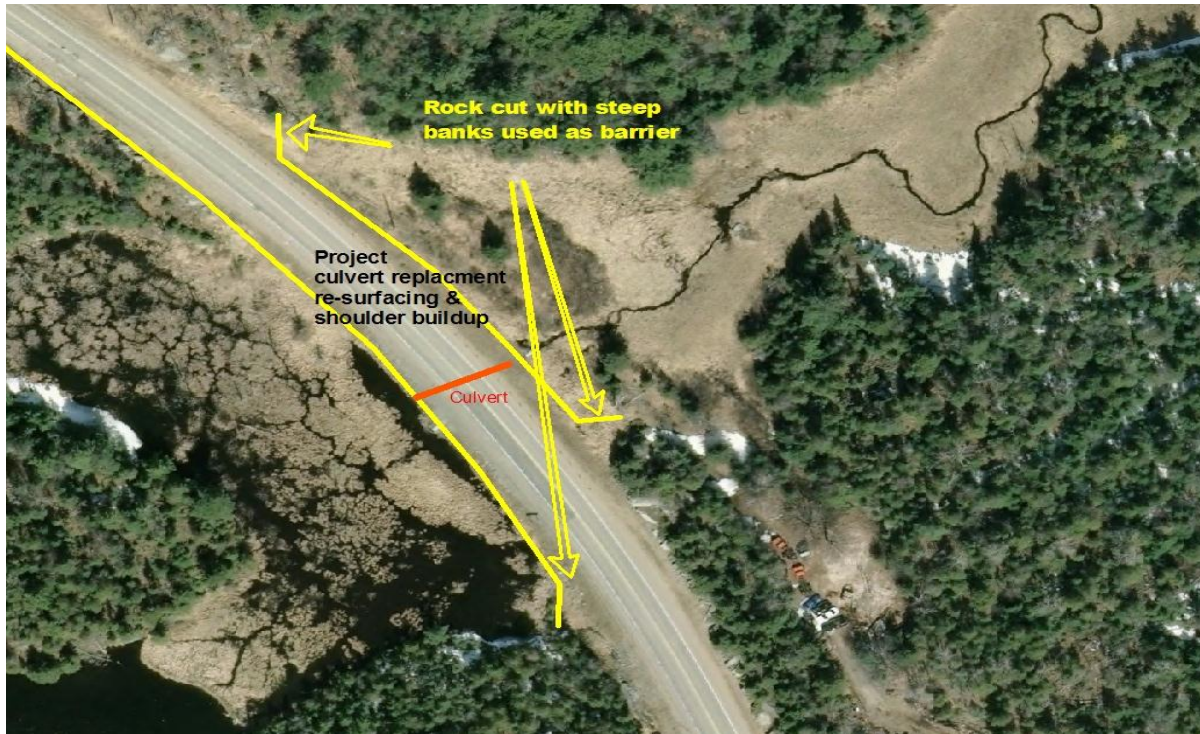
Figure 4: Using the natural features such as rock outcrops as barriers can help to reduce excessive and unnecessary fencing which can exclude or confine turtles from the work area
