TURTLE NESTS-ROAD SHOULDER MAINTENANCE BEST MANAGEMENT PRACTICES

A Guide for Municipalities

Written by: Leora Berman, The Land Between charity.

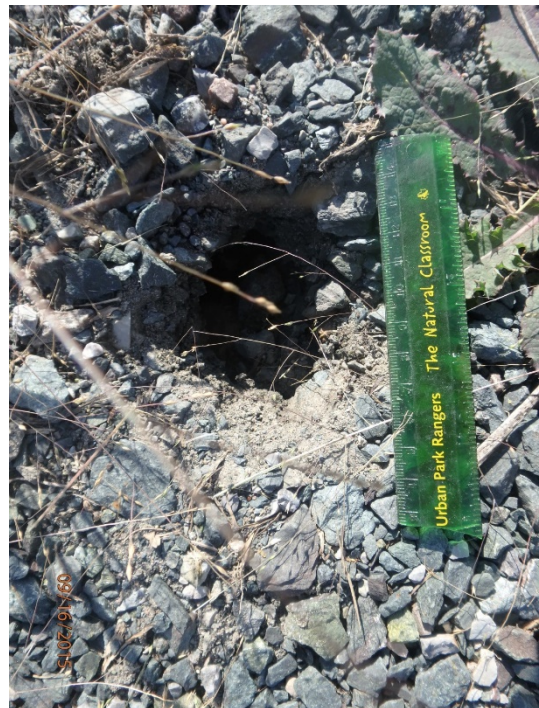
- Turtles may create several dummy nests, digging out small holes and then filling them in. This behaviour may be a means of testing site conditions or may be attempts to disguise the true nest site from the multitude of predators. Therefore, the presence of many small depressions within close proximity of one another with the substrate, or too, similar evidence of disturbances in the soil are suggestive of nests.

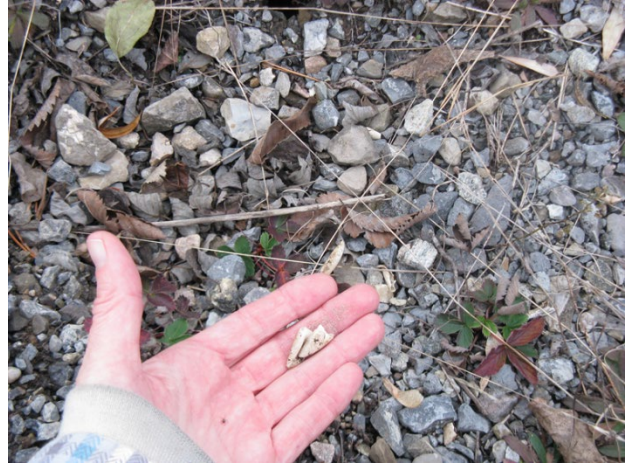
- In addition, the type of substrate as well as the location of the substrate, although not reliable, are determining factors for turtle nesting. Areas containing mixed sand and even with significant gravel are preferred nesting material for many turtles (Snapping, Blanding's, Wood, Northern Map and Painted turtles). Add to this, the presence of these substrates when close to or adjacent to wetland and aquatic areas, and candidate nesting sites can be determined. Therefore, unpaved road shoulders provide ideal nesting sites for these turtle species.

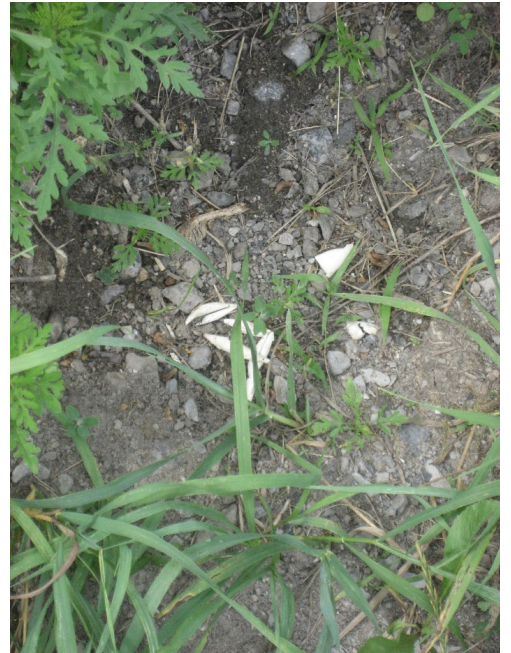
- Finally, and unfortunately, the presence of turtle shell fragments (thin arched bone pieces) resulting from road kills may add some additional support to the previous evidence when locating nesting areas.

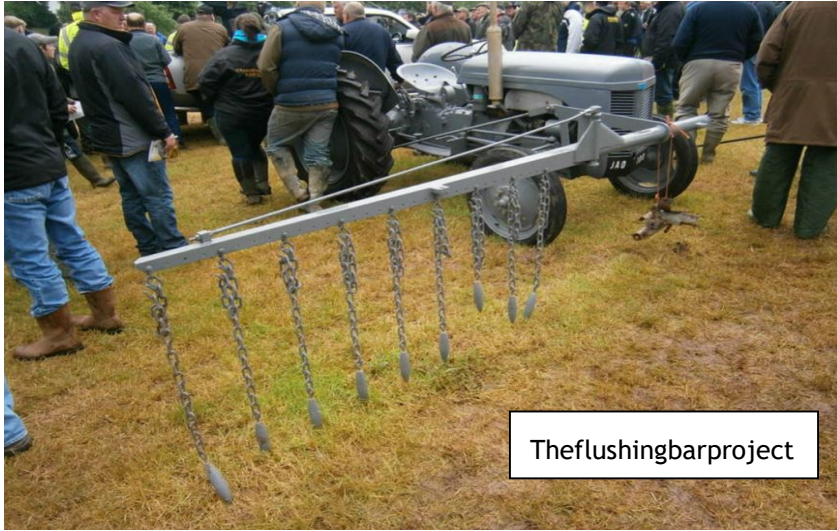
During vegetation management, in areas that are mowed or cut, site reconnaissance cannot be entirely effective in determining species presence. Flushing bars, designed by Ducks Unlimited, are plastic bars placed on mowers, which forewarn animals especially grassland birds and nesting waterfowl, breeding birds and also turtles and snakes, of the presence of the mower.
